D-764
Old Hurlock Library
Hurlock
c. 1892
Private

Historic Properties Form

Inventory No. D-764

historic Hurlock Library

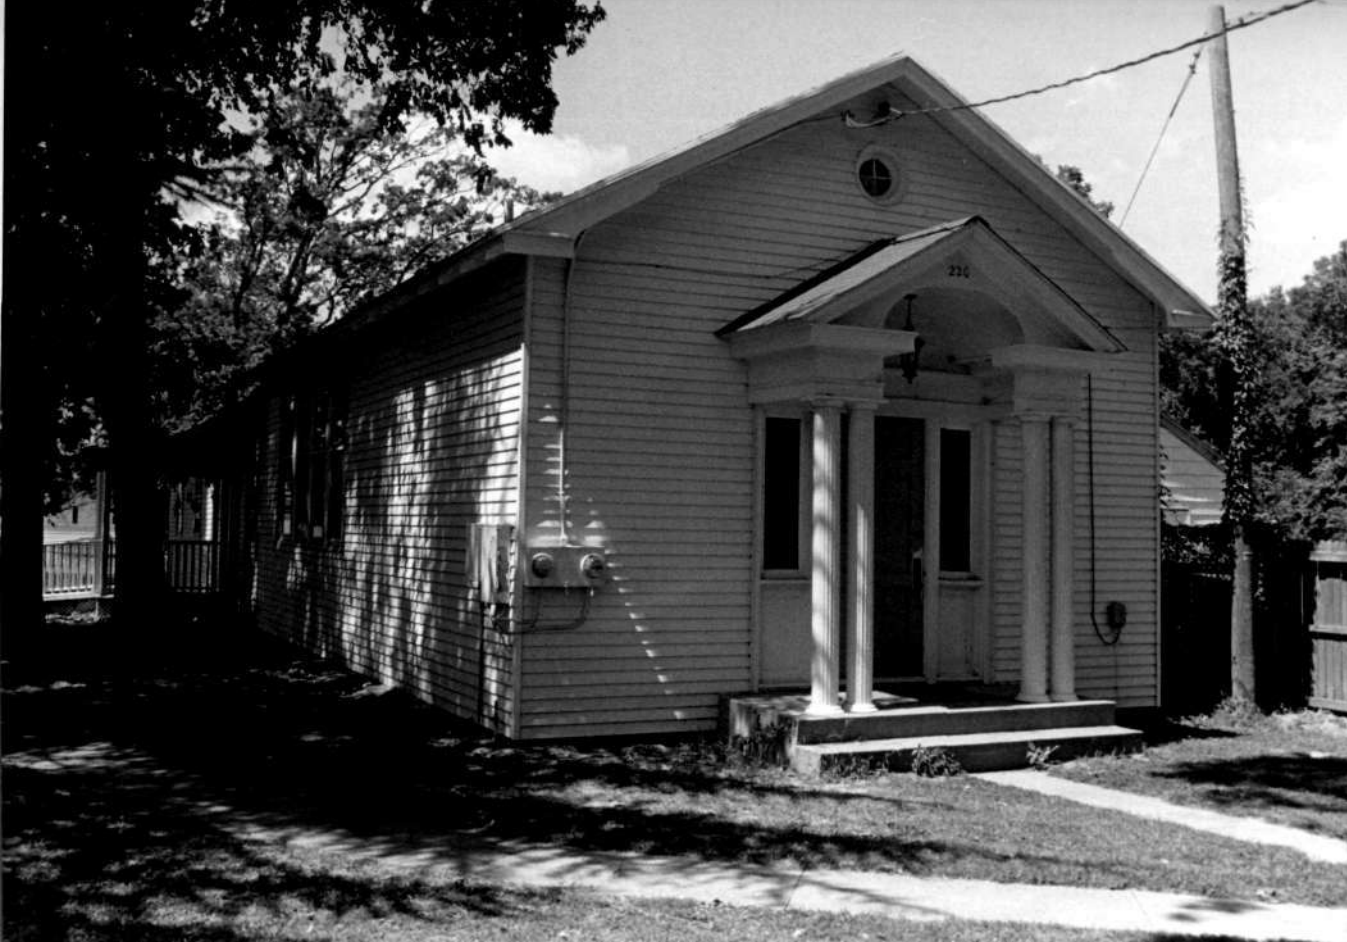
D-764

Dating around 1892, the single-story rectangular frame library building, originally erected as a one-room elementary school, is supported on a low brick foundation, and the exterior is clad with aluminum siding over plain weatherboards. The medium pitched gable front roof is covered with asphalt shingles. Attached to the back of the late nineteenth century structure is a slightly shorter single story gable roofed addition erected in 1977-78. The east (main) façade is a one-bay elevation with a center entrance sheltered by a Colonial Revival portico. Supported on a poured concrete stoop, replacement Doric columns rise to a gable roof distinguished by an arched ceiling. The portico has an extended eave with boxed cornices trimmed with crown molding typical of the early twentieth century. The portico as well as the six-panel front door and sidelights date to the 1929 remodeling of the former school. Fixed in the gable end of the front elevation is a small, round four-pane window. The edge of the roof is finished with an extended eave and simple curved bargeboard.

NORTHEAST ELEVATION
